# DEMONSTRATION REPORT

Underwater Advanced Time-Domain Electromagnetic System

ESTCP Project MR-201313

MARCH 2017

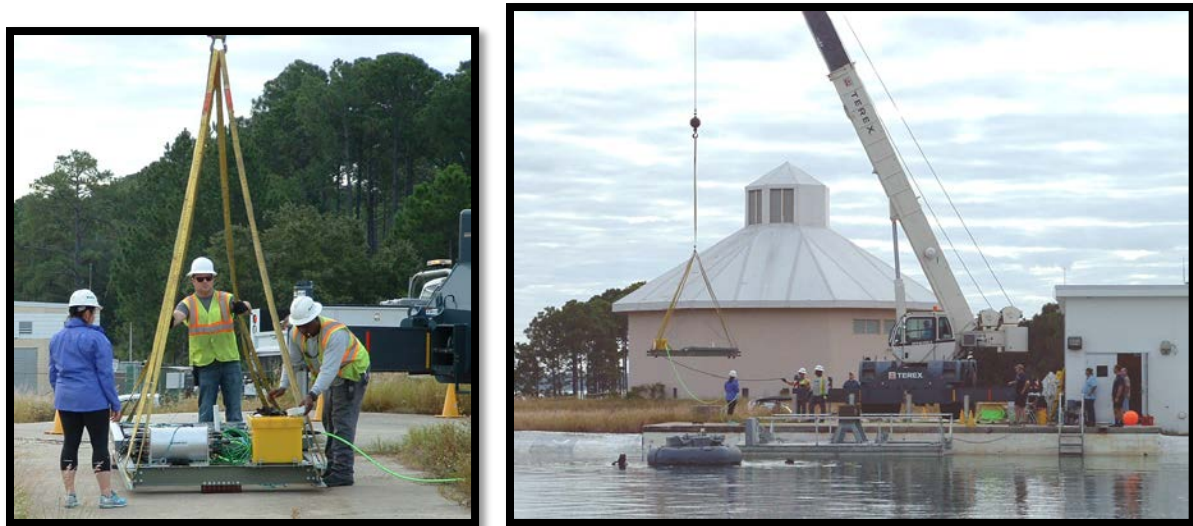
NSWPCD provided a crane (see **Figure 5**), operator, and riggers for deployment of the system into and out of the pond, an inner-tube shallow water lift system with a 2500lb lift capacity crane (see **Figure 6**), and a team of divers to maneuver the inner-tube and the system.

**Figure 5. Crane provided by NSWPCD for transfer of system from land into water.**

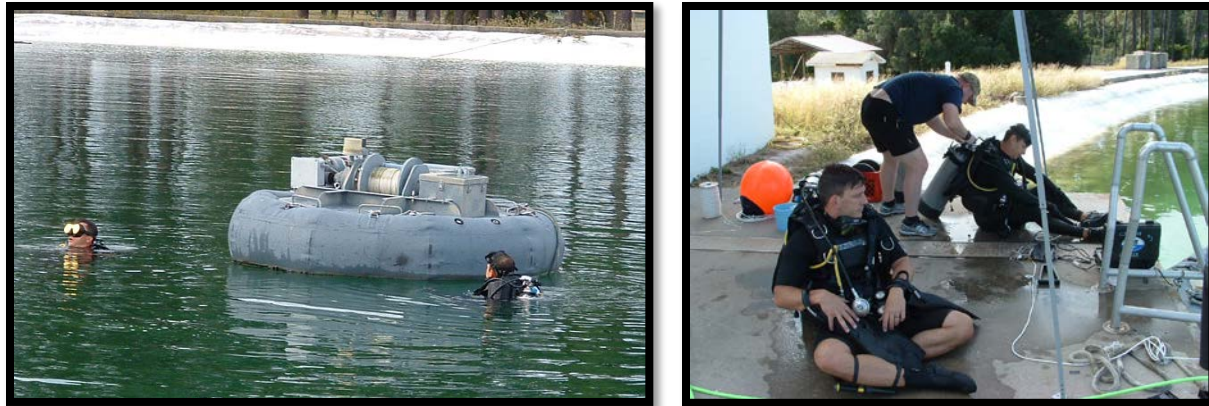
Figure 6. Inner-tube shallow water lift system and dive team for maneuvering system from within the water.

The array was easily deployed into the pond using the crane and maneuvered in the water using the inner-tube shallow water lift system (donut) and winch. The divers provided some feedback with respect to modifications, such as handles on the frame, holes in the base of the system for visibility to the bottom, cable management, and improvements to the attachment mechanism for the ropes used to deploy the system with the crane and winch.

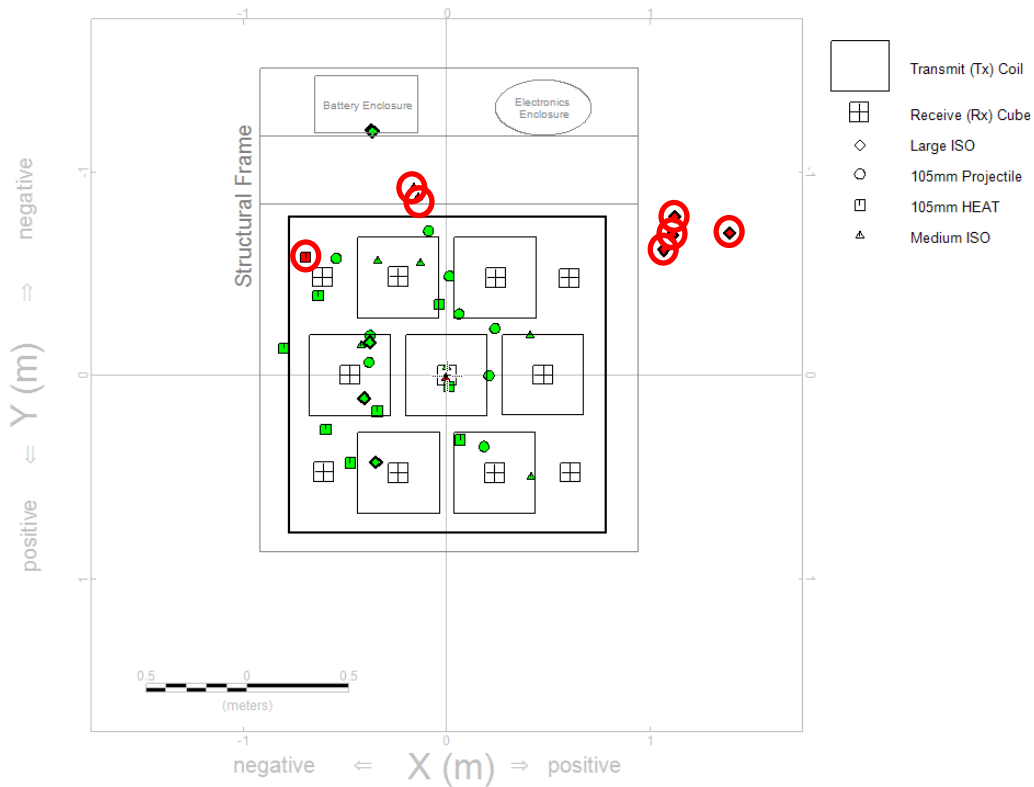
For the most part the measurements produced good fit quality and polarizabilities which were good matches to the library polarizabilities. The true target locations relative to the array are unknown; however, the board tests, discussed in the previous section, indicate an expected match of fit locations to within a few cm of the true target locations. To the extent that the fit locations reflect the actual target location, it appears that most of the time the array was positioned reasonably well over the target. With decent fit quality poor library matches typically occurred for targets outside the array footprint, as illustrated by **Figure 18**. The target locations in which the fit quality was okay but the match to the corresponding library item was less than 0.9, are circled on the figure. One of the medium ISO measurements (O5-6-1) did not converge to an acceptable fit using one or two dipole fit models and the library match failed; visual inspection of the data suggests that the array was not actually over the target and this is a bad

measurement. This measurement is represented by the red triangle at the center of the plot. Only two measurements (O1-3-1, O1-3-2) which fit to locations well outside the array footprint (near  $X = -0.4$ ,  $Y = -1.2$ ) had good ( $> 0.9$ ) library matches. They are both measurements on the large ISO taken during the first sequence.

**Figure 18. Buried target fit locations for ISOs and inert munitions. Green locations indicate  $> 0.9$  library match and red indicate  $< 0.9$ . Circled locations indicate where the fit quality was good ( $> 0.5$ ) but the match to the corresponding library item was  $< 0.9$ .**
